仮置場名:m547d009 立野下 南  
 仮置場所在地:浪江町大字立野字堂眼塚10外

1. 点検結果

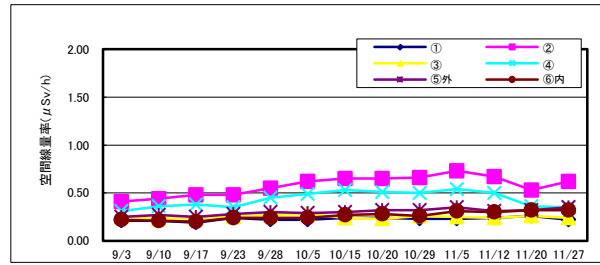
2. 空間線量率 単位:  $\mu\text{Sv/h}$

11/5	11/12	11/20	11/27
①	0.23	0.24	0.26	0.22
②	0.73	0.67	0.53	0.62
③	0.25	0.24	0.26	0.24
④	0.54	0.50	0.36	0.35
⑤外	0.35	0.31	0.32	0.35
⑥内	0.31	0.30	0.32	0.32
