仮置場名:m547d006 酒田

仮置場所在地:浪江町大字酒田字南2丁目5~16

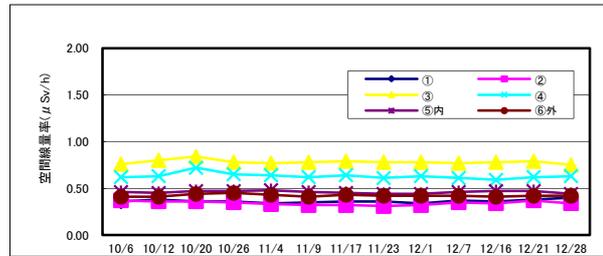
2. 空間線量率 単位: $\mu\text{Sv/h}$

12/1	12/7	12/16	12/21	12/28
①	0.34	0.37	0.36	0.38	0.40
②	0.32	0.35	0.34	0.37	0.34
③	0.78	0.77	0.78	0.79	0.75
④	0.63	0.61	0.59	0.62	0.63
⑤内	0.44	0.46	0.47	0.47	0.44
⑥外	0.42	0.42	0.41	0.42	0.42

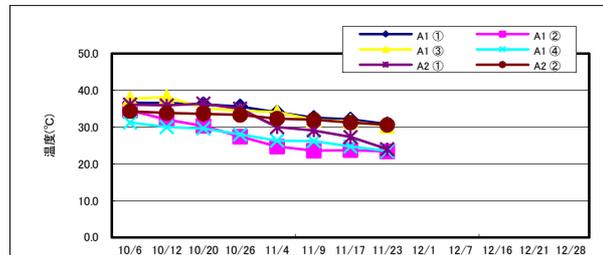
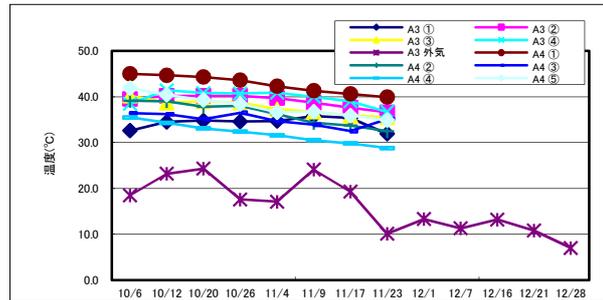
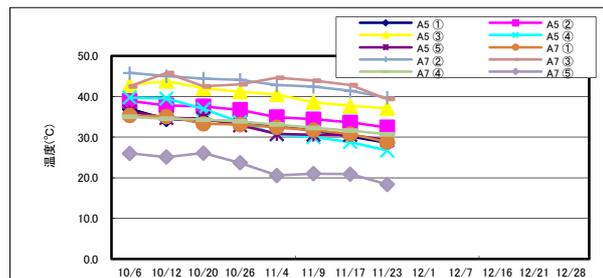
3. 除去物内部温度 単位: $^{\circ}\text{C}$

12/1	12/7	12/16	12/21	12/28
A1	①				
	②				
	③				
	④				
A2	①				
	②				
A3	①				
	②				
	③				
	④				
外気	13.3	11.3	13.2	10.8	7.0
A4	①				
	②				
	③				
	④				
	⑤				
A5	①				
	②				
	③				
	④				
	⑤				
A7	①				
	②				
	③				
	④				
	⑤

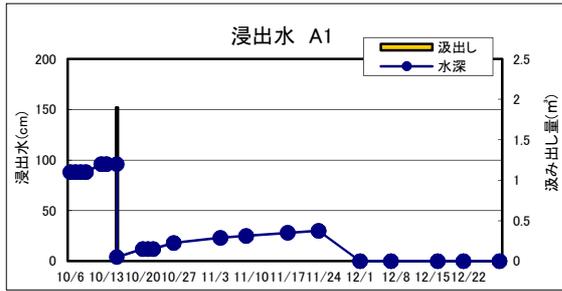
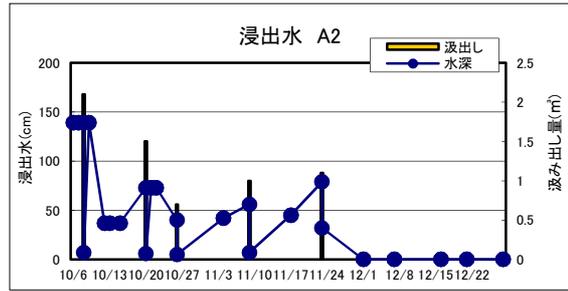
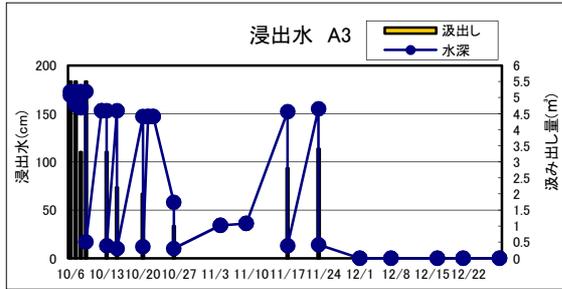
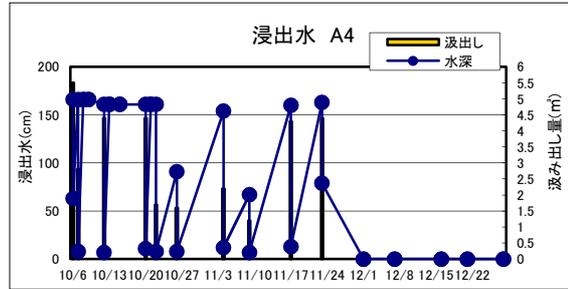
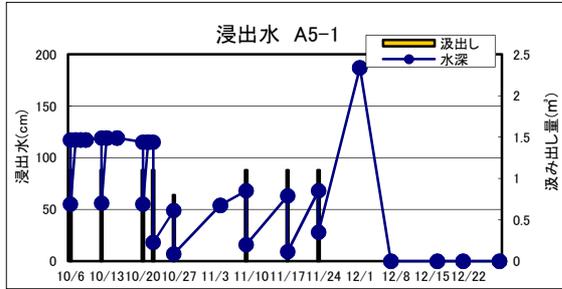
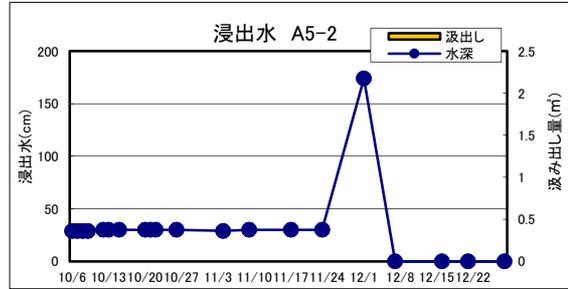
〔水深〕 単位:cm

孔底	12/1	12/7	12/16	12/21	12/28
A1	208					
A2	204					
A3	209					
A4	213					
A5-1	209	187				
A5-2	212	174				
A6	205	54	61	26	32	39
A7-1	212					
A7-2	207					
A8	208	55	58	10	11	13
A9-1	207	62	10	24	25	24
A9-2	207	80	38	50	54	60
A10	207	60	16	30	35	42
A11-1	207	18	25	31	33	37
A11-2	207	14	14	15	14	14
B1-1	210	40	43	46	48	50
B1-2	205	37	37	40	40	40
B2-1	206	74	22	48	46	54
B2-2	211	17	17	18	18	17
B3-1	208	131	31	61	21	32
B3-2	200	6	6	6	5	6
B4-1	209	38	44	64	15	18
B4-2	212	8	8	8	8	8
B5-1	213	60	19	35	40	48
B5-2	207	22	26	32	34	36
B6-1	210	54	26	45	54	63
B6-2	209	21	21	21	21	21
B7-1	210	74	37	53	61	71
B7-2	205	29	28	28	29	29
