堤上第2ため池 測定結果

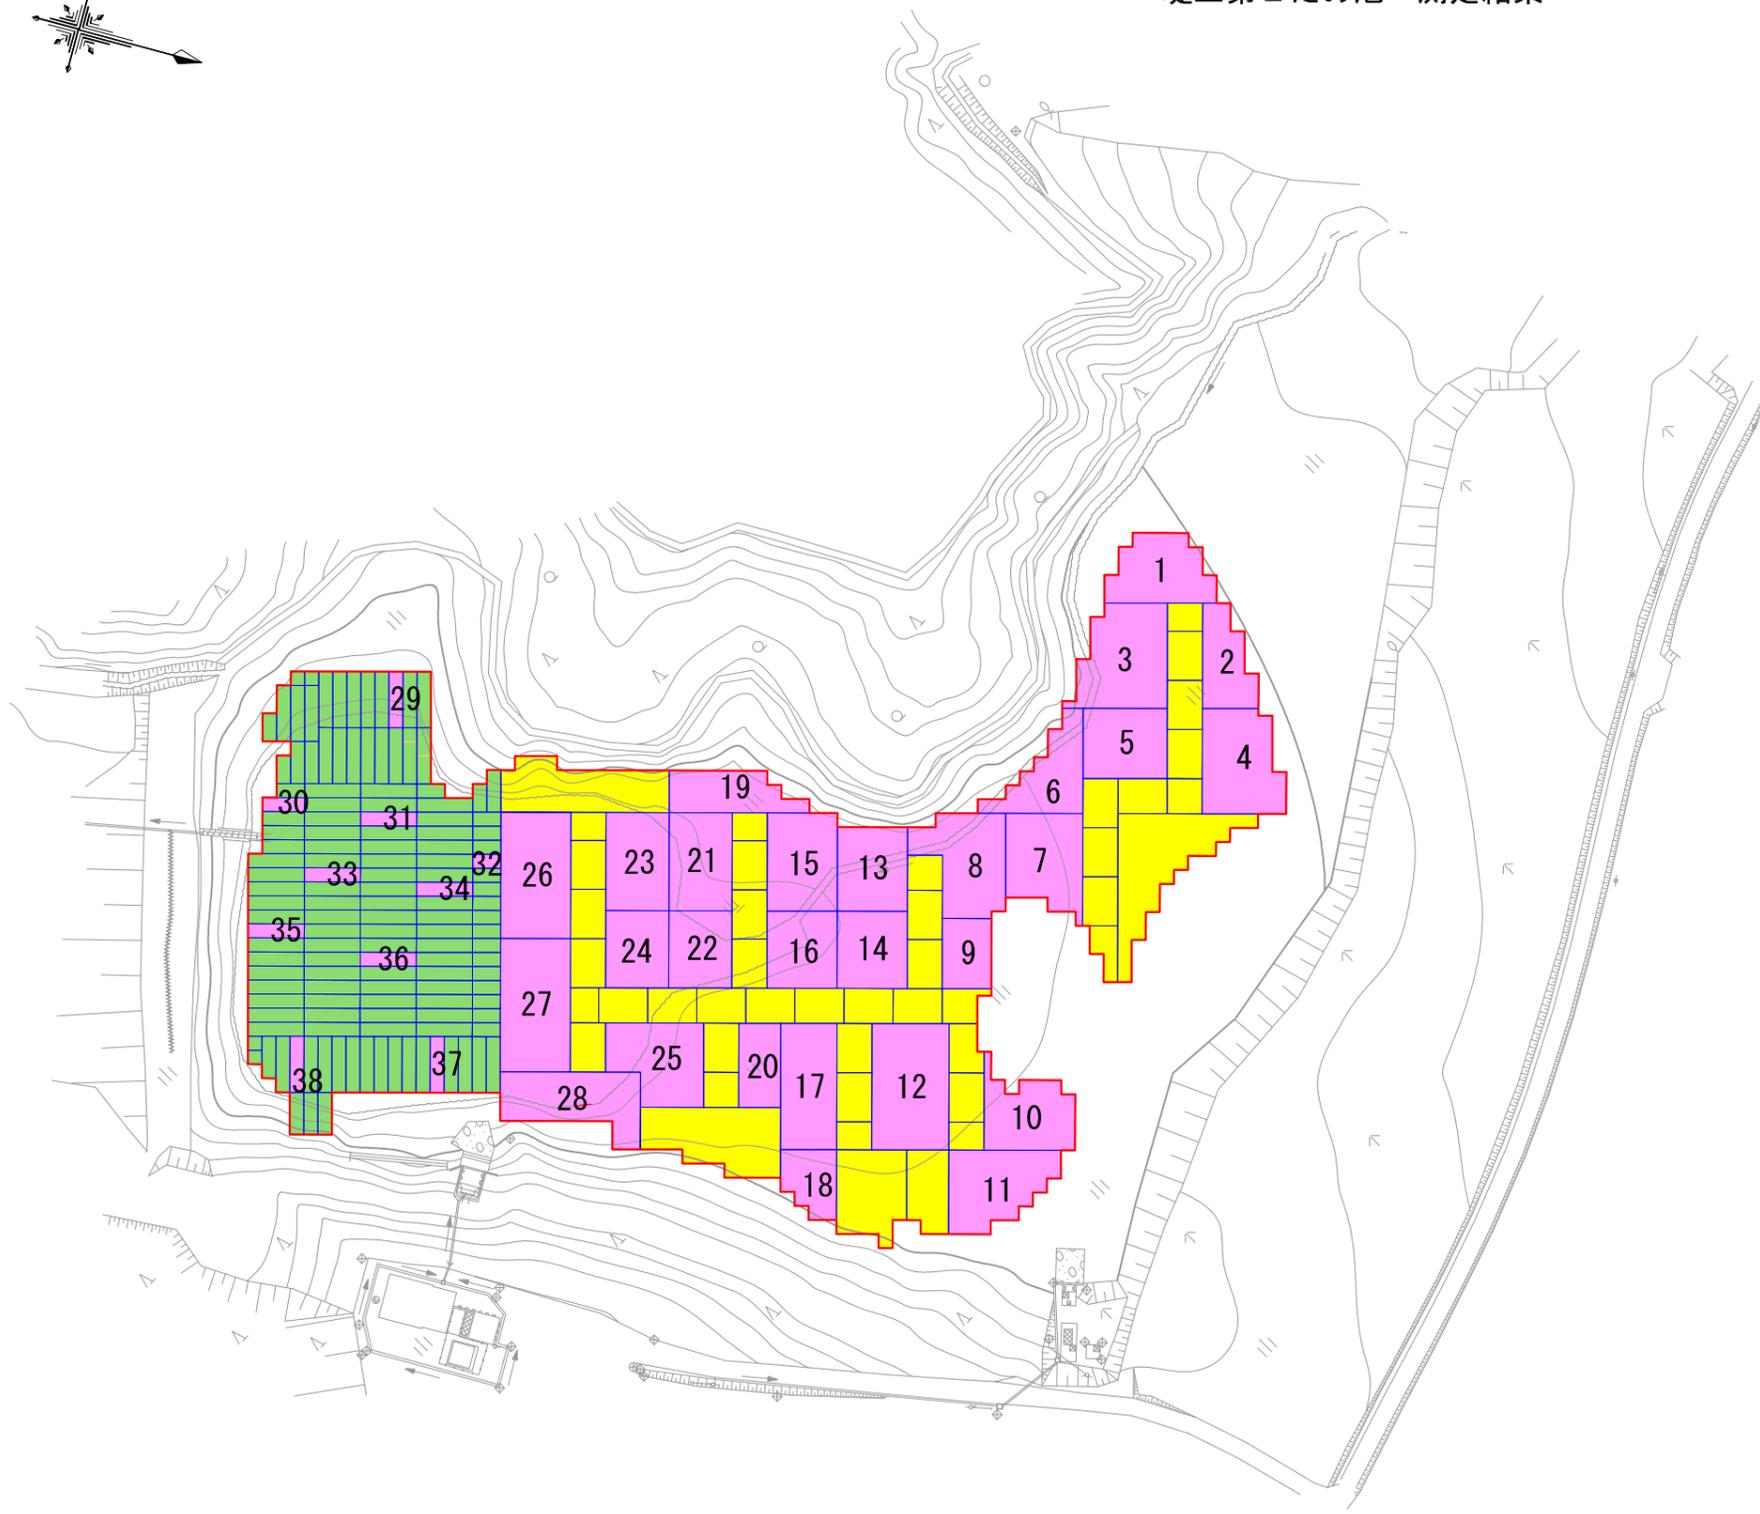
凡 例	
	対策範囲
	浚渫施工
	掘削施工
	品質管理点

池名	品質管理地点	対策前	対策後	低減率
		(¹³⁴ Cs, ¹³⁷ Cs合算) Bq/kg(dry)	(¹³⁴ Cs, ¹³⁷ Cs合算) Bq/kg(dry)	
堤上第2ため池	1	13,000	650	95.0%
	2	11,000	1,400	87.3%
	3	9,300	350	96.2%
	4	9,800	200	98.0%
	5	16,000	780	95.1%
	6	18,000	1,500	91.7%
	7	14,000	95	99.3%
	8	21,000	1,400	93.3%
	9	8,900	340	96.2%
	10	21,000	440	97.9%
	11	14,000	240	98.3%
	12	19,000	110	99.4%
	13	19,000	210	98.9%
	14	19,000	650	96.6%
	15	20,000	140	99.3%
	16	15,000	840	94.4%
	17	22,000	170	99.2%
	18	14,000	検出下限値以下	99.7%
	19	14,000	810	94.2%
	20	9,500	140	98.5%
	21	18,000	270	98.5%
	22	30,000	95	99.7%
	23	20,000	140	99.3%
	24	18,000	検出下限値以下	99.8%
	25	16,000	1,900	88.1%
	26	18,000	250	98.6%
	27	31,000	検出下限値以下	99.9%
	28	20,000	64	99.7%
	29	17,000	440	97.4%
	30	12,000	450	96.3%
	31	40,000	550	98.6%
	32	40,000	3,000	92.5%
	33	47,000	760	98.4%
	34	40,000	1,000	97.5%
	35	11,000	560	94.9%
	36	42,000	550	98.7%
	37	31,000	1,200	96.1%
	38	23,000	280	98.8%
	平均	20,566	582	97.2%
