# 山田ため池 測定結果

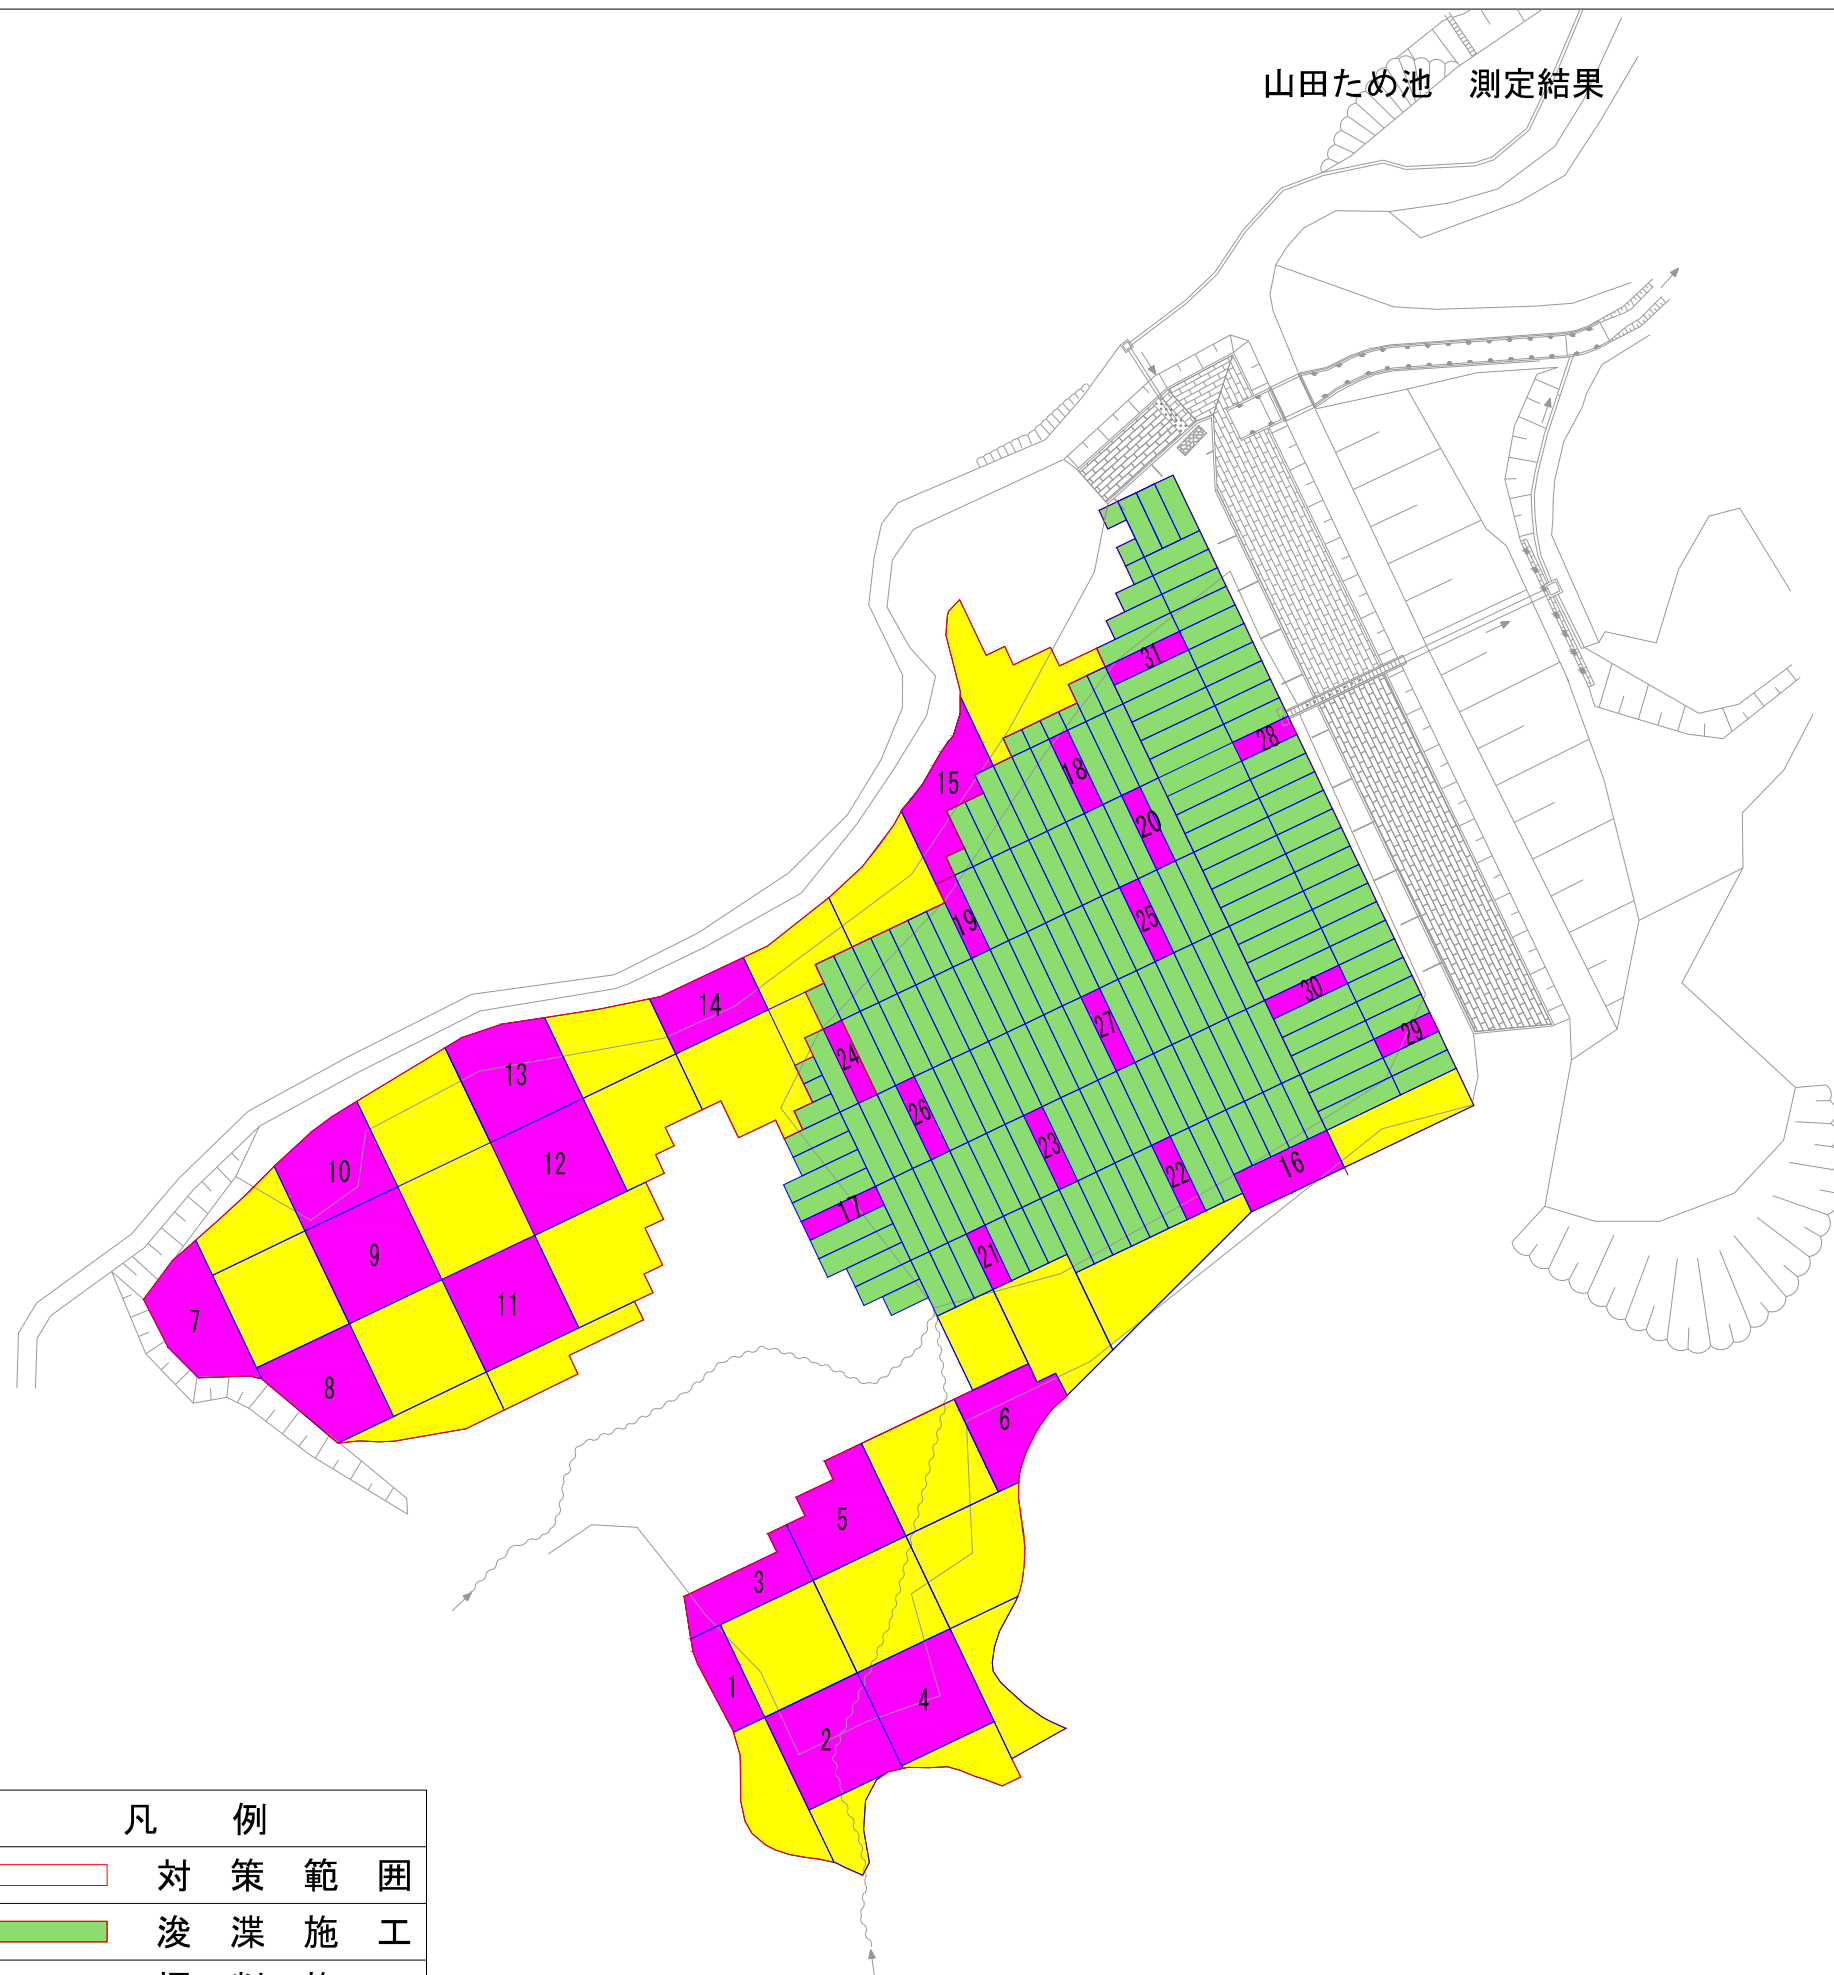
凡 例	
<span style="border: 1px solid red; display: inline-block; width: 15px; height: 10px;"></span>	対 策 範 囲
<span style="background-color: #90EE90; border: 1px solid black; display: inline-block; width: 15px; height: 10px;"></span>	浚 渫 施 工
<span style="background-color: #FFFF00; border: 1px solid black; display: inline-block; width: 15px; height: 10px;"></span>	掘 削 施 工
<span style="background-color: #FF69B4; border: 1px solid black; display: inline-block; width: 15px; height: 10px;"></span>	品 質 管 理 点

池名	品質管理地点	対策前	対策後	低減率
		( <sup>134</sup> Cs, <sup>137</sup> Cs合算) Bq/kg(dry)	( <sup>134</sup> Cs, <sup>137</sup> Cs合算) Bq/kg(dry)	
山田ため池	1	29,057	769	97.4%
	2	27,364	116	99.6%
	3	28,287	58	99.8%
	4	57,363	536	99.1%
	5	15,992	48	99.7%
	6	13,246	39	99.7%
	7	70,298	240	99.7%
	8	21,755	1,353	93.8%
	9	28,780	896	#REF!
	10	20,257	93	99.5%
	11	12,407	1,764	85.8%
	12	12,189	627	94.9%
	13	15,678	207	98.7%
	14	11,923	1,643	86.2%
	15	9,146	844	90.8%
	16	18,214	104	99.4%
	17	11,344	52	99.5%
	18	17,710	62	99.6%
	19	15,752	3,998	74.6%
	20	29,869	332	98.9%
	21	13,132	102	99.2%
	22	27,301	5,646	79.3%
	23	26,261	2,130	91.9%
	24	12,799	6,772	47.1%
	25	32,696	547	98.3%
	26	21,611	141	99.3%
	27	27,838	60	99.8%
	28	21,311	1,643	92.3%
	29	32,715	2,914	91.1%
	30	32,309	160	99.5%
	31	22,756	200	99.1%
	平均	23,786	1,100	95.4%
