麦ノ沢第2ため池 平面図

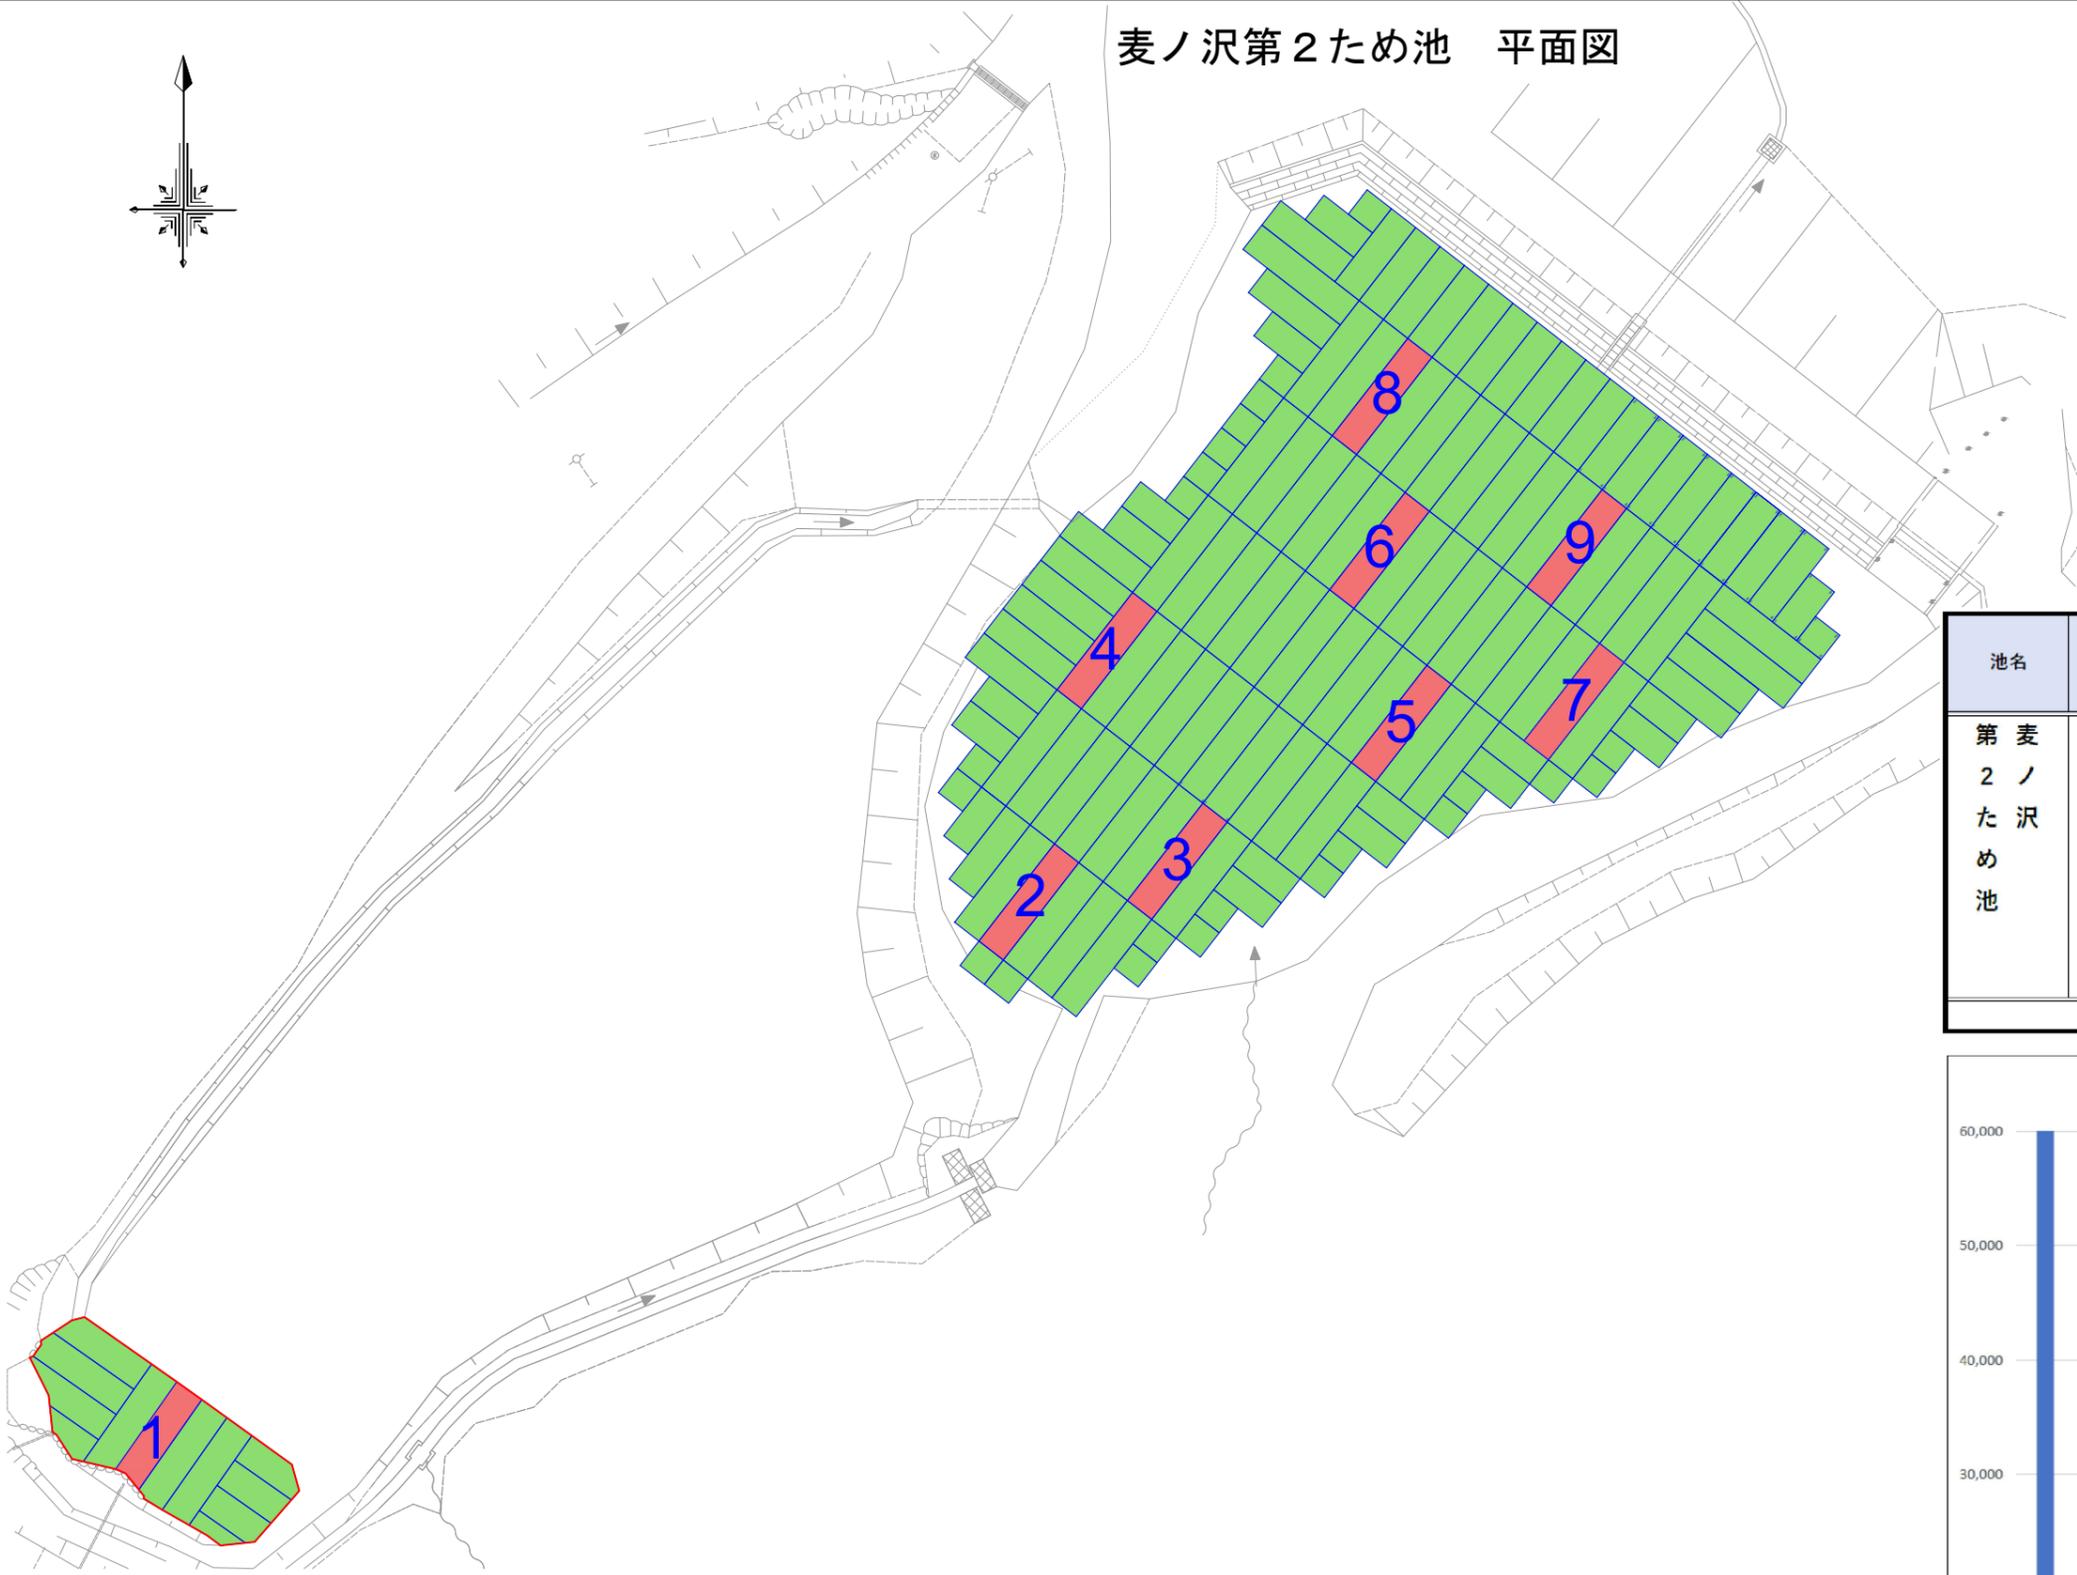
凡 例	
	対 策 範 囲
	浚 渫 施 工
	品 質 管 理 点

池名	品質管理地点	対策前	対策後	低減率	
		(¹³⁴ Cs, ¹³⁷ Cs合) Bq/kg(dry)	(¹³⁴ Cs, ¹³⁷ Cs合) Bq/kg(dry)		
第 2 た め 池	(浚渫)	1	85,127	864	99.0%
		2	17,969	370	97.9%
		3	10,224	295	97.1%
		4	19,017	416	97.8%
		5	50,305	718	98.6%
		6	51,089	572	98.9%
		7	55,479	409	99.3%
		8	44,535	282	99.4%
		9	59,742	492	99.2%
	平均	43,721	491	98.9%
