山田ため池(再対策) 測定結果

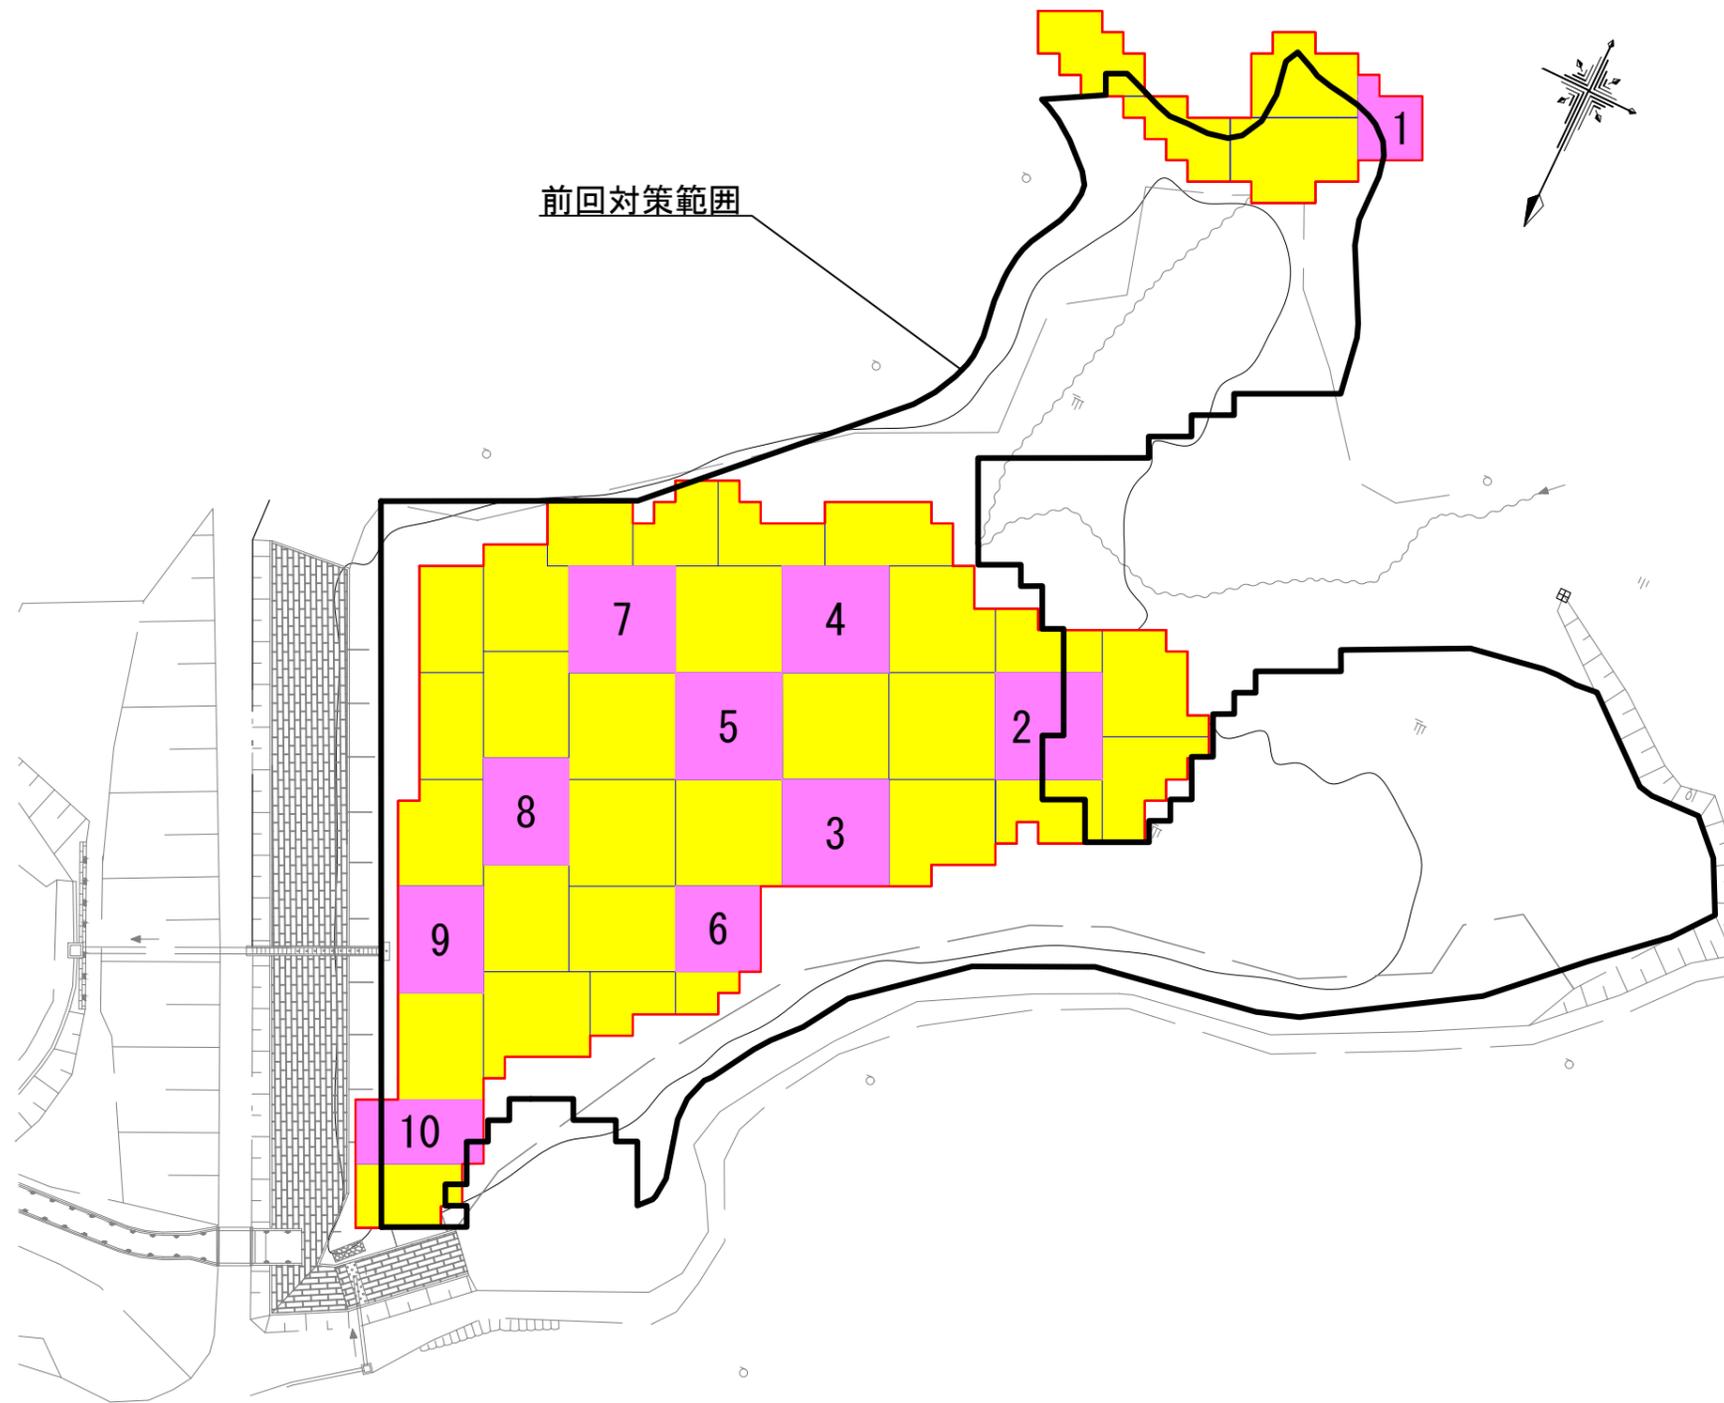
池名	品質管理地点	対策前 ( <sup>134</sup> Cs, <sup>137</sup> Cs 合算)	対策後 ( <sup>134</sup> Cs, <sup>137</sup> Cs 合算)	低減率	
		Bq/kg(dry)	Bq/kg(dry)		
山田ため池	(掘削)	1	35,797	508	98.6%
		2	15,721	57	99.6%
		3	15,872	612	96.1%
		4	9,168	1,955	78.7%
		5	16,188	711	95.6%
		6	12,399	265	97.9%
		7	19,802	962	95.1%
		8	17,448	215	98.8%
		9	16,873	1,848	89.0%
		10	13,369	109	99.2%
	平均	17,264	724	95.8%

※検出下限値 = 40Bq/kg
